**Maryland Historical Trust**

Maryland Inventory of Historic Properties MHT Number BA-2718 Historic Bridge Inventory Maryland State Highway Administration Maryland Historical Trust Name and SHA No. 3001 **Location:** Street/Road Name and Number: US Route 1 over Little Gunpowder Falls City/Town:Reckord Vicinity X **County: Baltimore** Ownership: X State County Municipal Other This bridge projects over: \_\_Road\_\_Railway\_X\_Water\_\_Land Is the bridge located within a designated district: yes X no \_NR listed district\_\_NR determined eligible district \_locally designated\_\_other Name of District\_\_\_\_\_ **Bridge Type:** \_\_Timber Bridge \_Beam Bridge\_\_Truss-Covered\_\_Trestle \_\_Timber-and-Concrete \_\_Stone Arch \_Metal Truss \_\_Movable Bridge \_\_Swing \_Bascule Single Leaf\_Bascule Multiple Leaf \_\_Vertical Lift\_\_Retractile\_\_Pontoon X Metal Girder \_\_Rolled Girder X Rolled Girder Concrete Encased \_\_Plate Girder \_\_Plate Girder Concrete Encased \_\_Metal Suspension \_Metal Arch

Bridge Number 3001 carries U.S. 1 in a generally north-south direction over the Little Gunpowder Falls in the Baltimore County, Maryland. The approach to the roadway is level and has

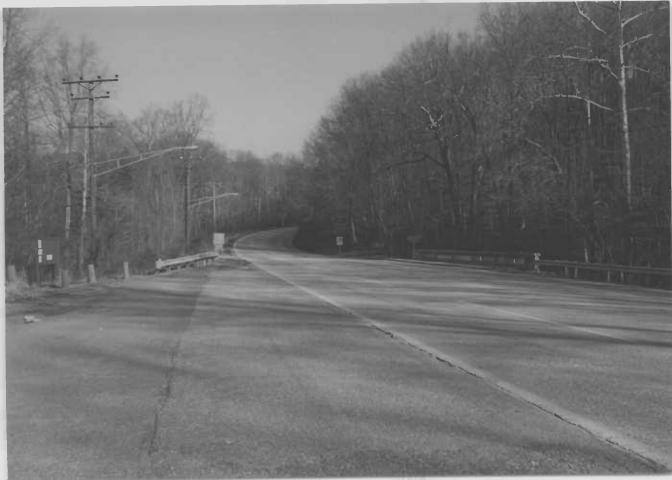
Name 3001-USI OVER LITTLE GUNPOWDER FAU
County/State BALTIMORE COUNTY/MD
Name of Photographer DAVE DIEHL
Date 1195
Location of Negative SHA
Description South APPROACH LOOKING NORTHEAST
Number 8 of 26

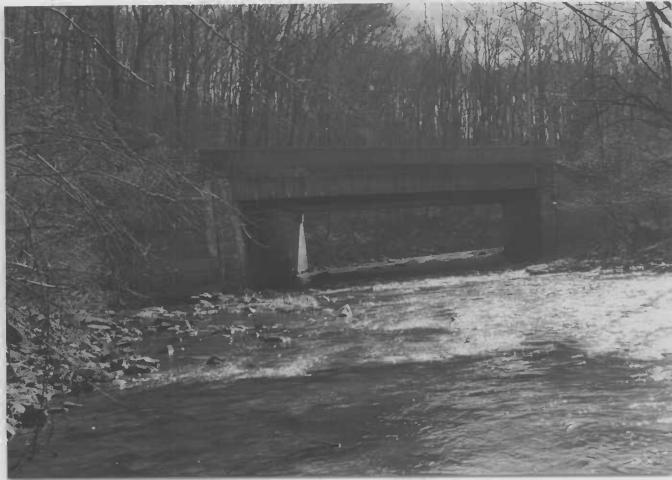
Number 26 of 36 6

Name 3001-USI OVER LATTLE GUNPOWDER FALLS
County/State BALTIMORE COUNTY/MO
Name of Photographer DAVE DIEHL
Date 195
7.0
Location of Negative SHA
Description WEST ELEVATION LOOKING
SOUTHEAST

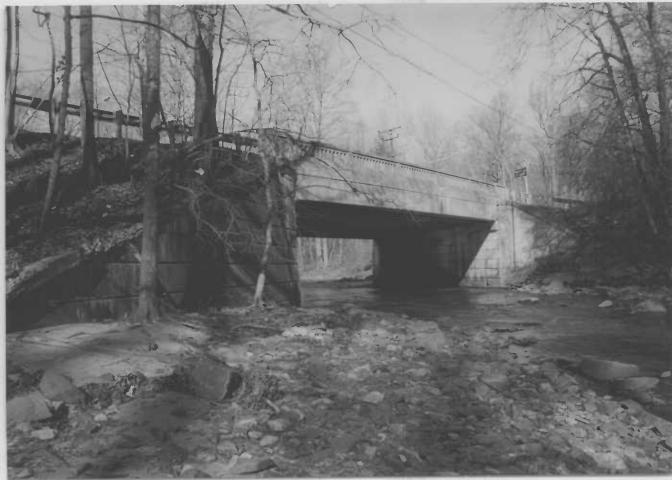
Number Hof 36 6

Name 3001-USI OVER LITTLE GUN POWDER FALLS County/State BALTIMORE COUNTY/MO Name of Photographer DAVE DIEHL Date 1195
Location of Negative SHA
Description EAST ELEVATION LOOKING

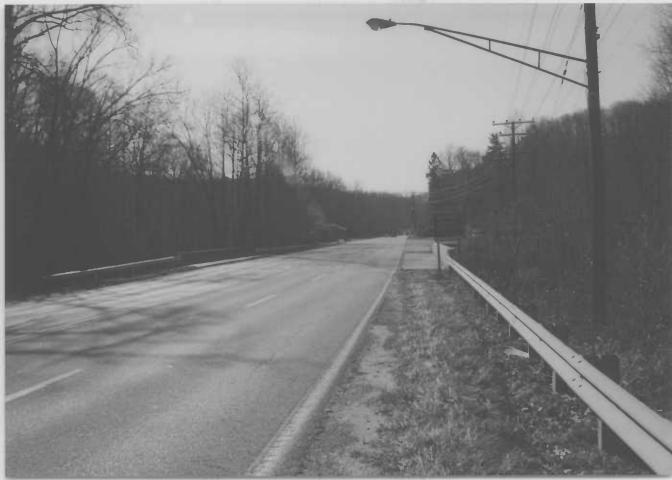
Number 20 of 36

Name 3001 - USI OVER LITTLE GUNFOWDER FAI	LS
County/State BALTIMORE COUNTY/MO	_
Name of Photographer DAVE DIEHL	
Date 195	
Location of Negative	
Description NORTH APPROACH LOOKING	
SOUTHWEST
